- Evaluation of Aircraft Armament Installation
 (F-86F with 206 RK Guns)
 Project Gun-Val (Title Unclassified)
- February 1955

AIR FORCE ARMAMENT CENTER
Air Research and Development Command
EGLIN AIR FORCE BASE, FLORIDA

Evaluation of Aircraft-Armament Installation (F-86F with 206 RK Guns)

Project Gun-Val

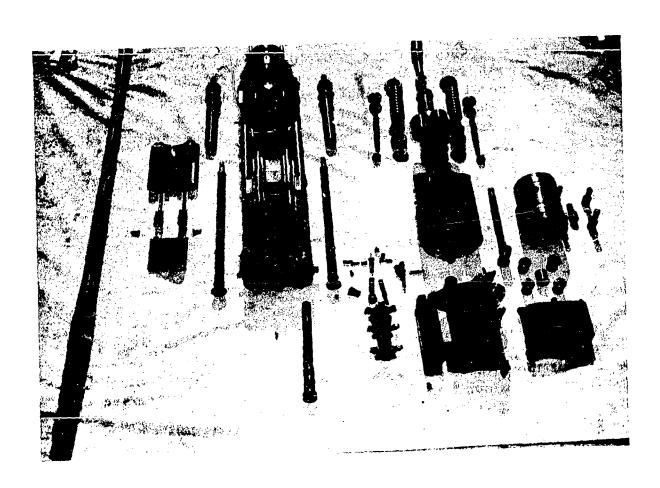
Fig. 1: 20mm 206 RK Gun

The Oerlikon 20mm 206 RK revolver gun (Figs. 1 and 2) is an automatic, gas-operated aircraft weapon, adaptable to either fixed or flexible mounting. It was designed to fire electrically-primed, link-belt-fed ammunition at a muzzle velocity of 3500 ft per sec and at a cyclic rate between 1600 and 1800 rounds per minute.

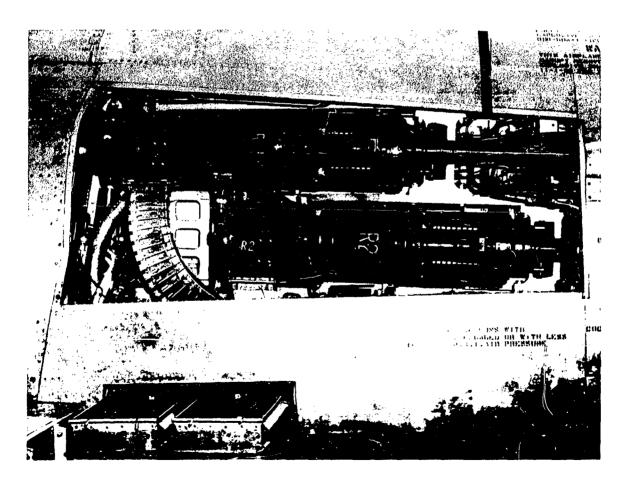
Fig. 3: The 206 RK Guns Installed in F-86F Aircraft

Four 206 RK guns are mounted in the F-86F test aircraft, two on each side of the fuselage (Fig. 3). Provision is made for the storage of 400 rounds (100 rounds per gun) of linked ammunition. Expended links are retained in the aircraft in order to minimize the movement of the center of gravity of the aircraft. Case ejection chutes are used to eject the expended cases from the aircraft.

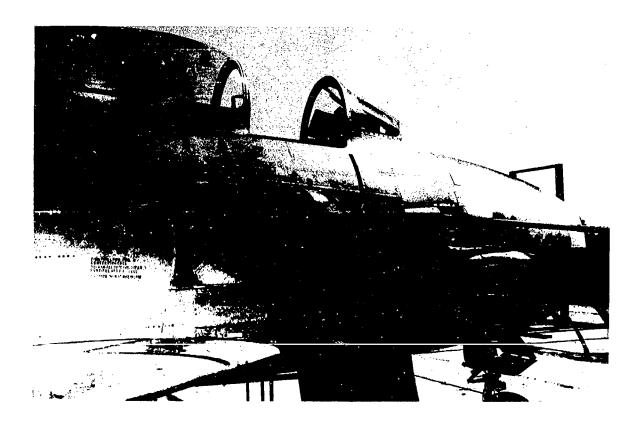
Fig. 4: View Showing Upper Right Gun Pivoted for Maintenance and Lower Right Gun in Normal Position

Access to the guns is facilitated by a mounting yoke at the forward end of the receiver. After the barrels are removed and the rear mounting lugs loosened, the gun can be pivoted as shown in Fig. 4 and serviced in that position.

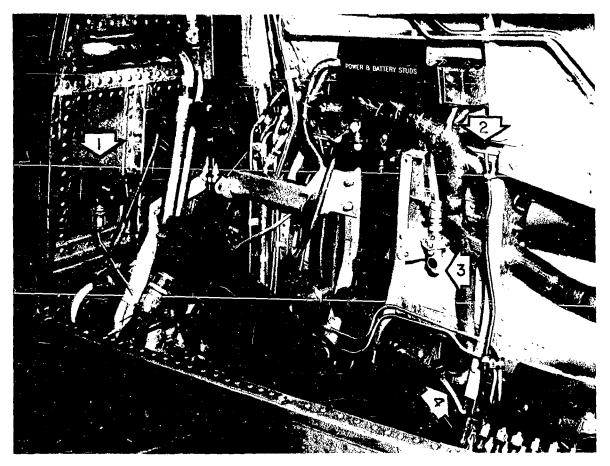
Fig. 7: Location of Fire-Eye Indicators (1 and 3) and Gun-Gas Pick-Ups (2 and 4) in Aft Portion of Right Gun Bay

A photoelectric-cell fire detection system (fire-eyes) consisting of eight cells (four in each gun bay) was installed to determine when flaming occurred. The output signal of the fire-eye was amplified and recorded on the oscillograph. Two of the fire-eye indicators are shown in Fig. 7.
